Site Audit & Traffic Management Plan

Southern Cross University, Lismore

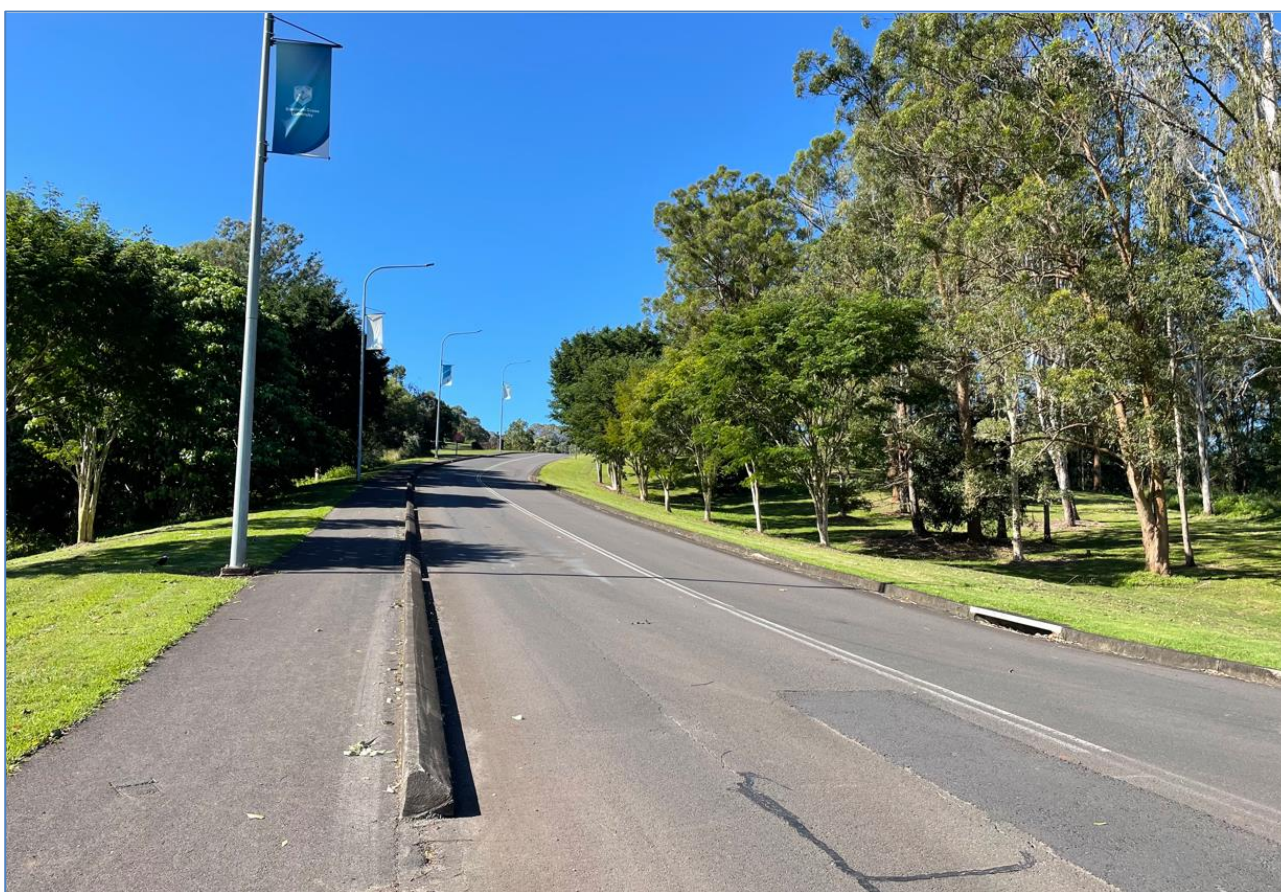
Figure 2.2: University Road (view eastbound)

University Road accessed from Ballina Road (state highway) via a roundabout, is subject to a 50kph speed limit. The road is a two lane (one in each direction), undivided local road. Carriageway widths vary between

7.3m and 8.0m. The topography of the road is such that there is an elevation drop of approximately 63m from Ballina Road to the site entry – this is equivalent to an average grade of 7.0% (1:14). The University entry gateway signage is located 890m from Ballina Road, and immediately upon entry through the site gateway, the road grade increases to almost 16% (1:6.25).

Pedestrians are provided for via a dedicated route along the outbound side of the road. The pathway is formed as part of the road surface seal and is delineated from the traffic lanes via a surface mounted kerb as shown in Figure 2.2.

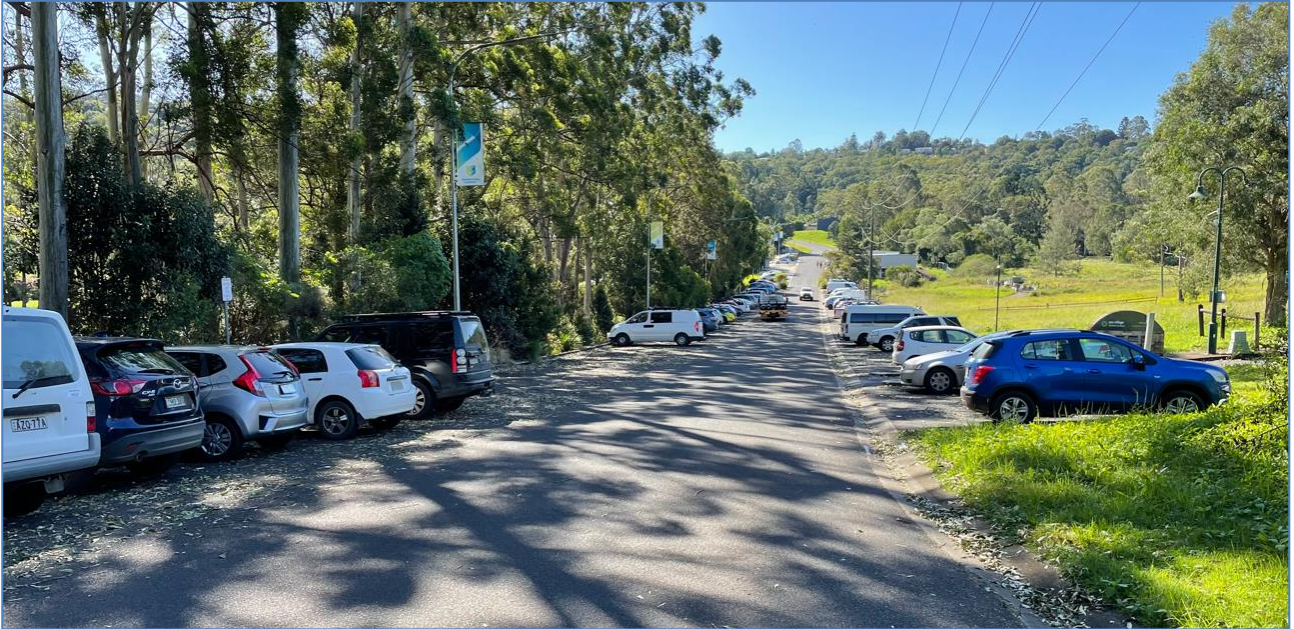
Figure 2.3: Rifle Range Road (view northbound)

Rifle Range Road accessed from Cynthia Wilson Drive (sub-arterial road) via a priority controlled intersection, is subject to a 50kph speed limit. The road is a two lane (one in each direction), undivided local (c class) road. Carriageway widths vary between 5.6m and 6.6m. The topography of the road is relatively flat with an average grade of less than 1% (1:100) up from Cynthia Wilson Drive to the north end of Rifle Range Road.

There are no formal pedestrian pathways along the majority of the length of the road – for a length of approximately 400m from the intersection. Pedestrians are then provided for via a dedicated footpath on

the western side, with a new footpath having been provided (post site visit) on the eastern side in front of the new demountable buildings.

Watts profile speed humps are provided at distances 88m, 325m and 460m from the intersection.

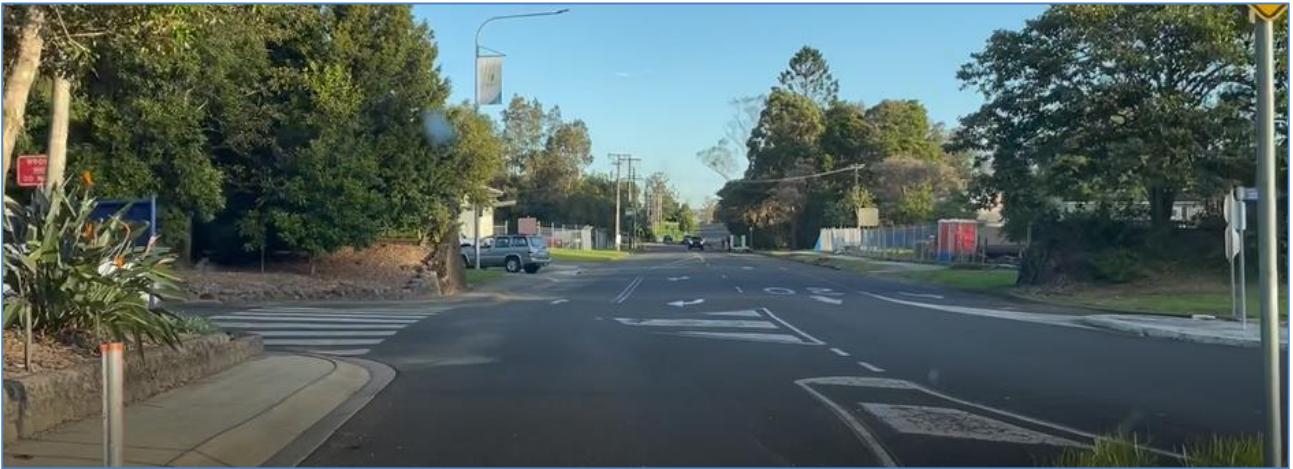
Figure 2.4: Military Road (view southbound)

Military Road provides the main access to the site and is subject to a 50kph speed limit. The road is a two lane (one in each direction), undivided sub-arterial road with kerbside parking. Carriageway widths vary between 8.8m and 12.3m kerb to kerb – with through lanes varying between 8.8m and 9.5m. The topography of the road is relatively flat with an average grade of less than 1.5% (1:65) up from Dalley Street (sub-arterial road) to the north end of Military Road.

Pedestrians are then provided for via a dedicated footpath on the western side of the road within the verge.

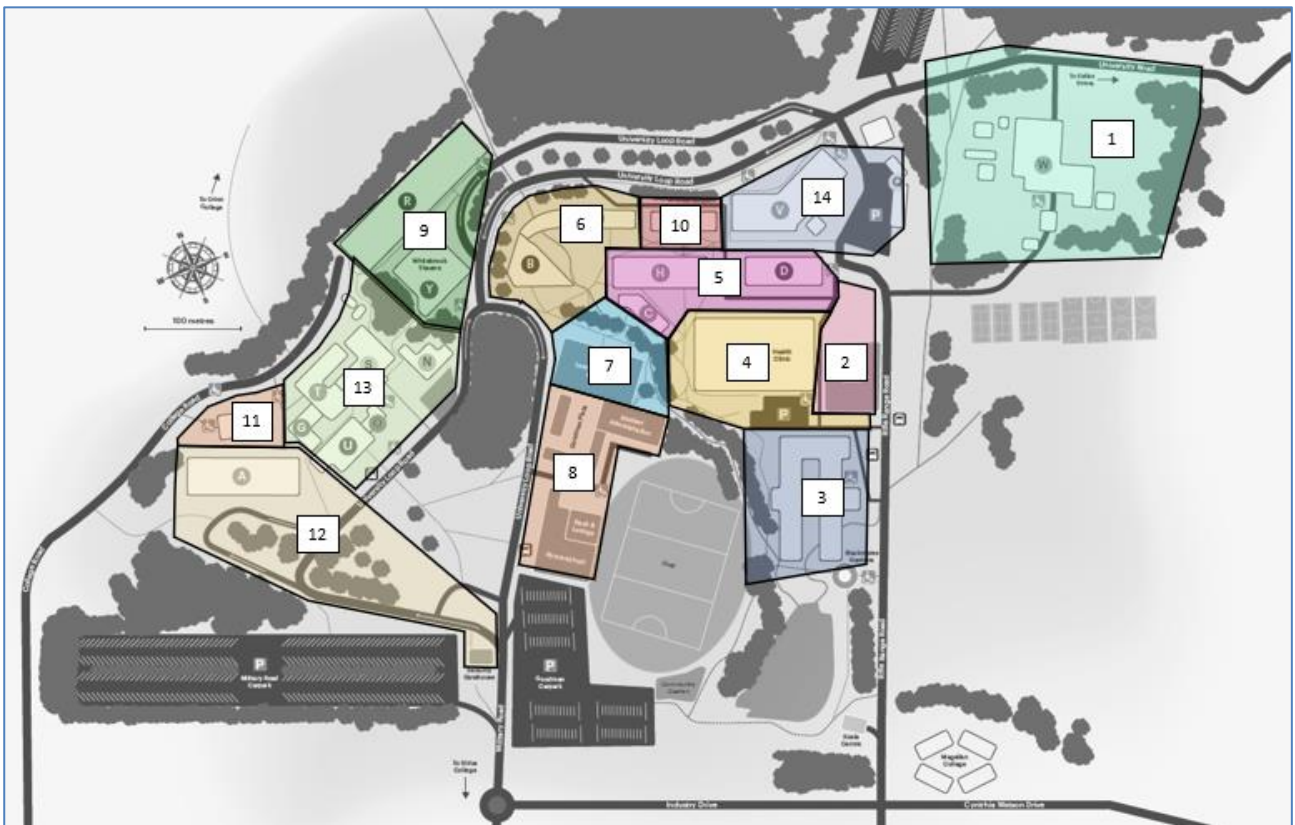
Figure 3.1: Site Areas Map

For ease of review, the site has been apportioned into 14 key areas as identified in Figure 3.1 and Table 3.1 below.

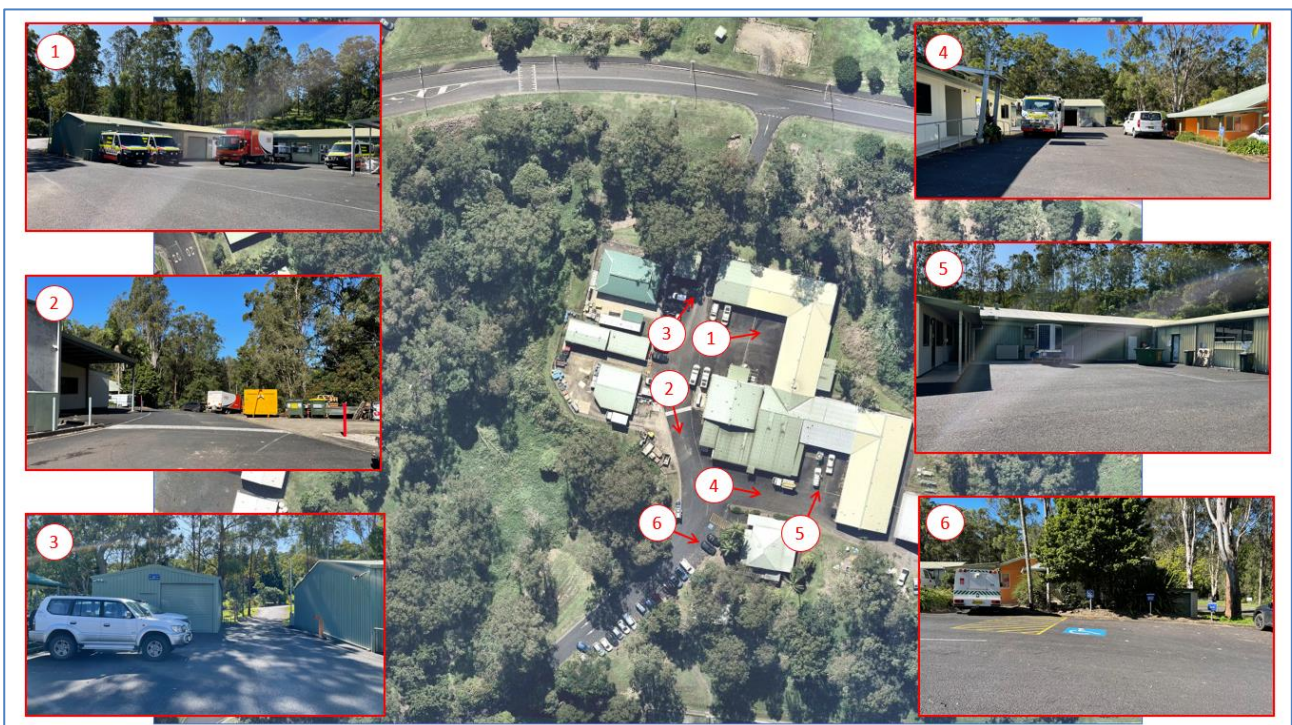
Figure 3.2: Site Area 1 Imagery

The cluster of structures house the SCU Property Services, mailroom, cleaning services, St John Ambulance and NSW Ambulance. The parking also supports public tennis and basketball courts. The area experiences frequent heavy vehicle movements from third party courier trucks and trades, in addition to ambulances.

At the time of the site inspection three ambulances were observed to be parked within the area (image 1) – however subsequent review of aerial imagery shows that up to 5 can be present. Further, the site inspection identified access to the chemical store was blocked by parked vehicles and third party delivery vehicles are required to reverse over an extended length to access the mail room.

It was also observed that whilst the speed limit of the campus is 20kph, the solar powered speed check sign on University Road is set incorrectly to advise drivers to obey a 40kph speed limit, immediately before the location where the 20kph speed limit starts.

1. It is recommended that the entry points to the storage sheds and chemical store be clearly line marked to prevent the parking of private vehicles in front of access gates. The provision of formal loading access areas will allow for loading activities to safely take place within the secure boundary fences of the property. The formalisation retains a total of 10 car parks along the western boundary of the area.

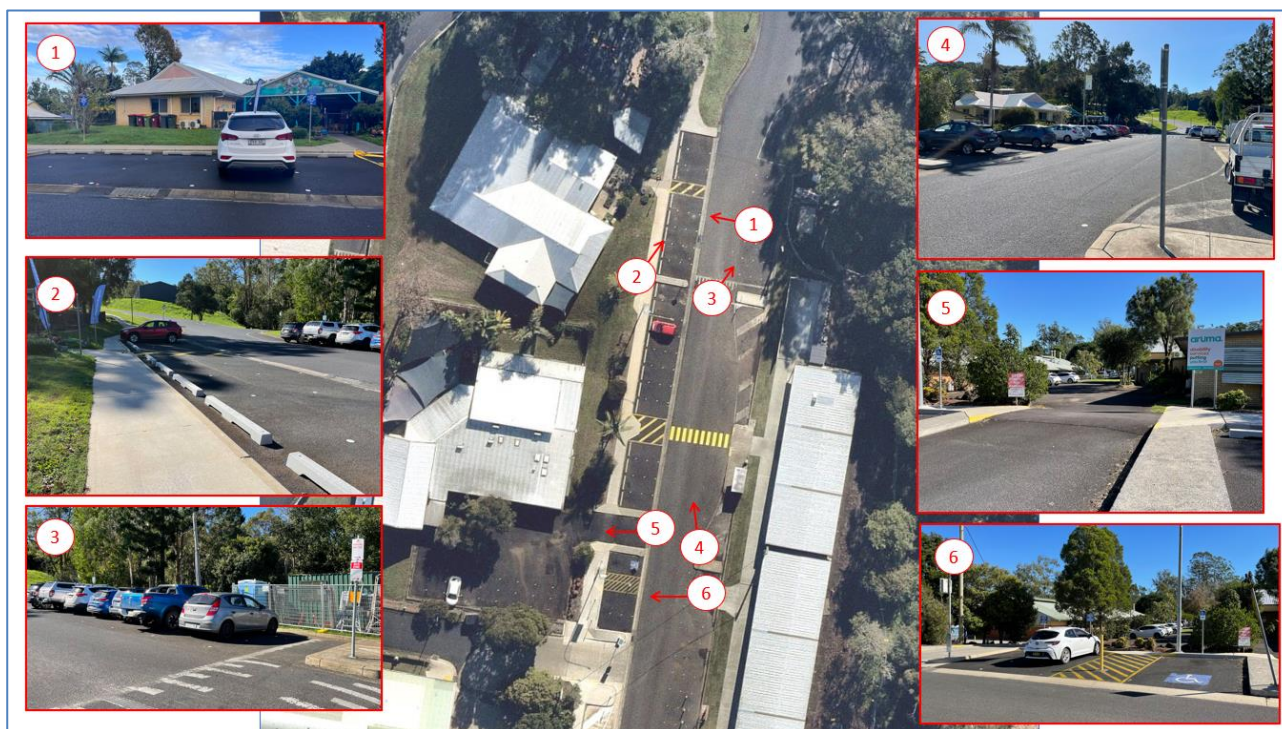
Figure 3.3: Site Area 2 Imagery

The Children's Centre has 7 dedicated drop off spaces at the immediate frontage of the property on Rifle Range Road (image 1 & 2) – these are signed accordingly. In addition, there are staff allocated spaces on the opposite side of Rifle Range Road (image 3).

Aruma has a dedicated off street parking area, reserved for the sole use of the property (image 5).

At the time of site visit it was noted that a series of demountable buildings were being constructed on the eastern side of Rifle Range Road for the use by Trinity Catholic College. TTM have received a plan view copy of design of the provision of the demountable buildings and note the following:

7. The bus or crossing is recommended to be repositioned to a location prior to the bus stop (in the vicinity of image 3).
8. SCU have advised that 6 of the Summerland allocated spaces on Rifle Range Road are able to be unallocated and returned to general parking.
9. The area would benefit from additional warning signage and identification of children in the area to reinforce reduced speeds and improve safety – including pedestrian crossing signage, and speed reduction measures such as humps on approach to the crossing.

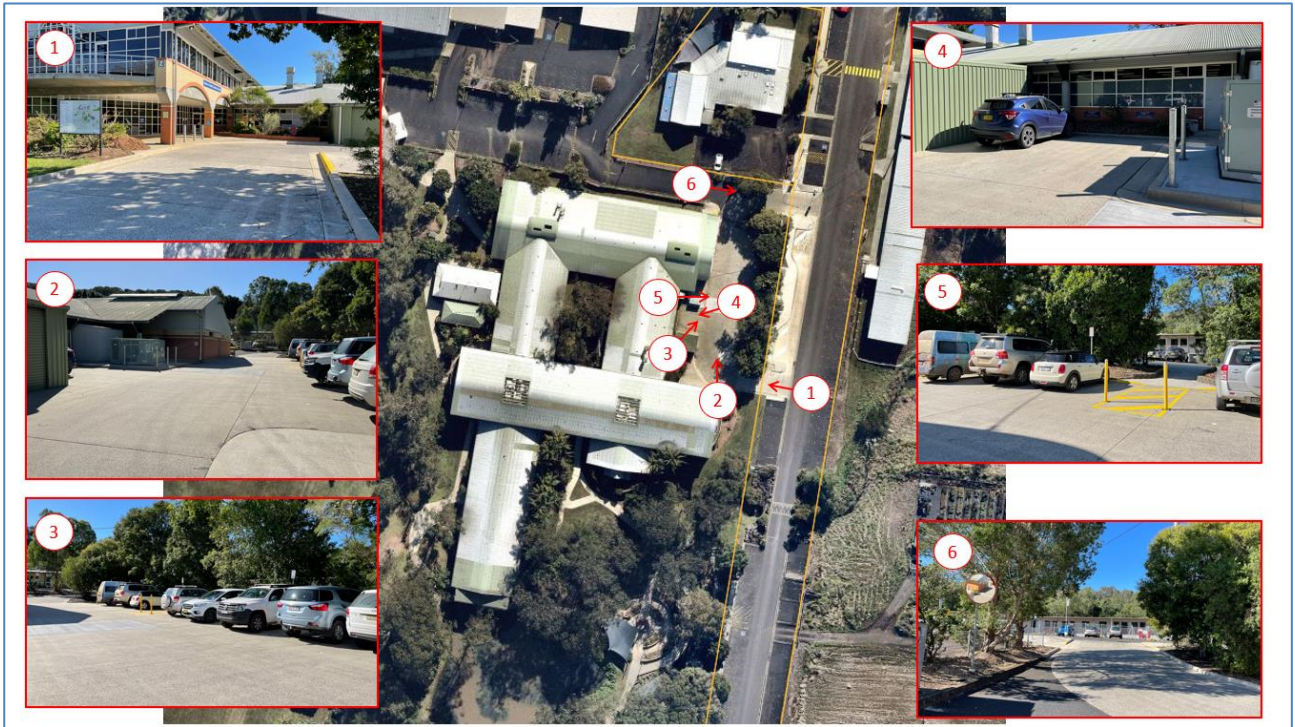
Figure 3.4: Site Area 3 Imagery

Accommodating the Faculty of Health there is a dedicated off street parking area (image 2), directly accessed from Rifle Range Road (image 1). There are three freely accessible spaces and two staff reserved spaces, with the remainder being accessible by student and staff permit holders (image 3).

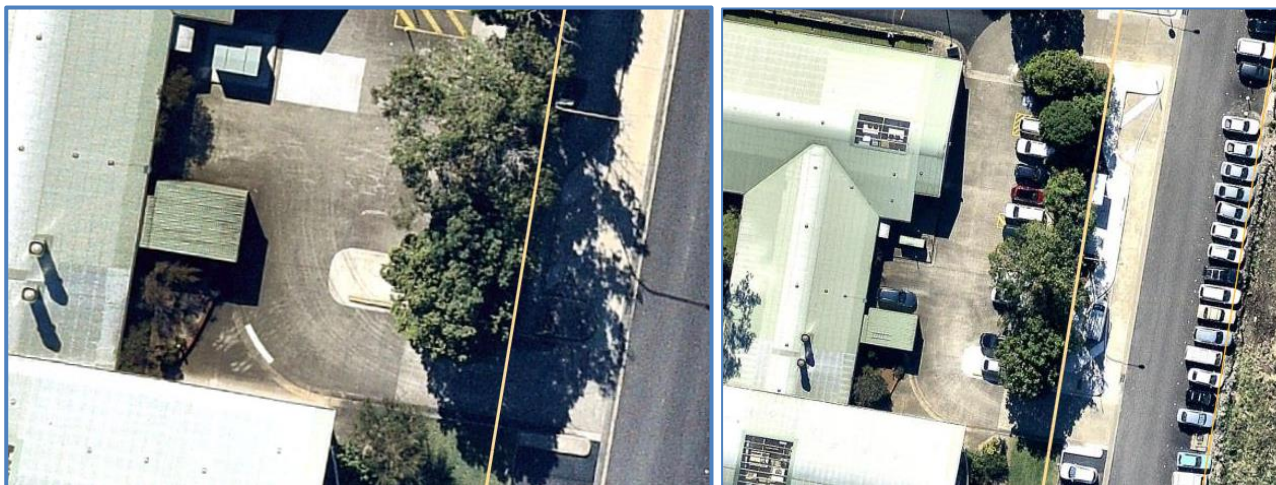
Figure 3.5: Site Area 3 Aerial Imagery

Review of aerial imagery of the car parking area shows evidence of heavy vehicles (expected to be refuse collection) travelling through the car park but mounting a kerb on entry from the south – which conflicts with the adjacent car parking space. There is also evidence of vehicles parking in the PWD shared area and pedestrian access – however this has been rectified with the installation of bollards. Examples of these instances are presented below.

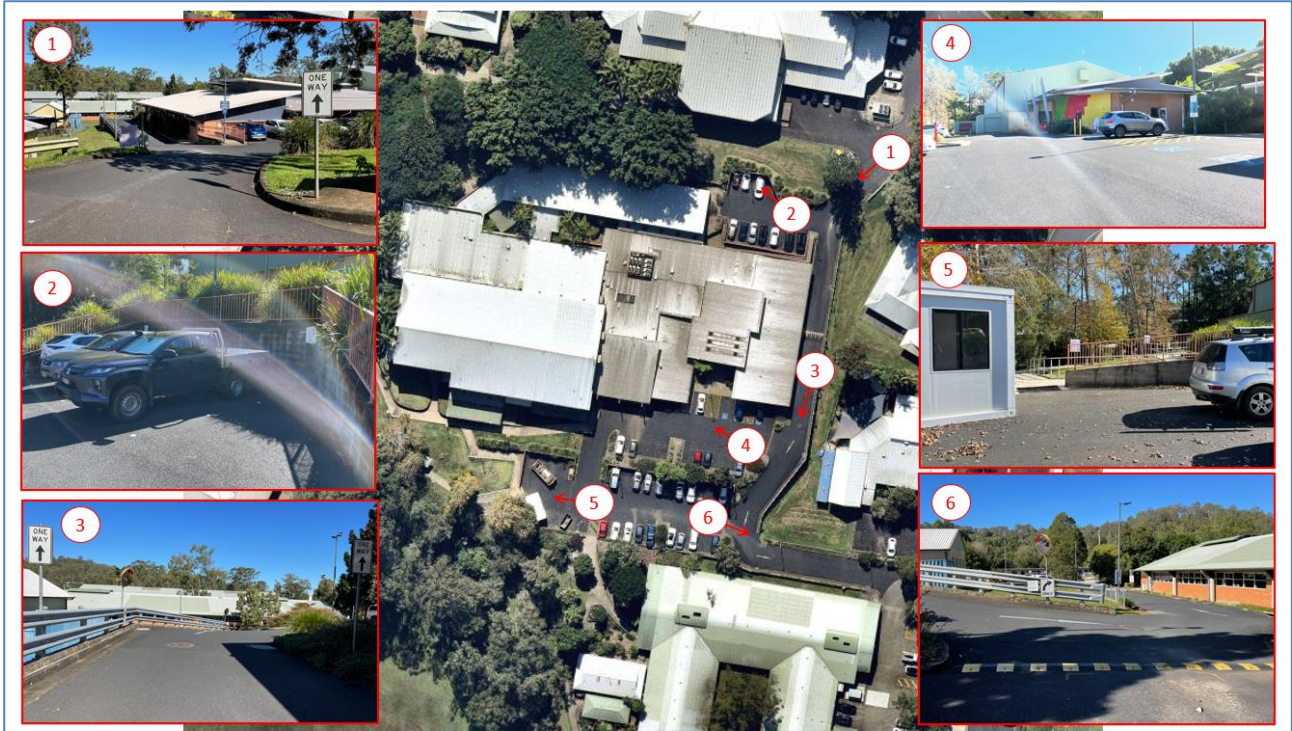
Figure 3.6: Site Area 4 Imagery

It was also observed that a demountable office/container has been placed in the south westernmost area of the car park, however this position impacts on the accessibility and compliance of a couple of parking spaces.

The area is accessed via a one way road from north to south, with localised instances of speed calming. Where the road meets the car park accesses, convex mirrors are provided due to limited visibility.

14. SCU have advised that 5 spaces to the rear (north) of the building are to be allocated. One for “Health North Coast” GP and 4 for “SCU Clinic” staff. As formal reserved for specific vehicles, it is recommended that these be towards the end of the aisle due to the common user of the spaces. Signage should be amended to accommodate these. In addition one space is to be converted to “loading bay” to accommodate smaller delivery vehicles. This should be towards the start of the area to allow for maximum visibility of the space to delivery drivers – it also maximise access and manoeuvring into and out of the space.

16. BCA recommends that PWD spaces be provided at a rate of 1 space per 50 standard spaces. The parking area includes less than 50 spaces and as such a minimum of 1 PWD space is required to be provided. It is recommended however that a minimum of 2 be provided given the mix of uses supported by the parking

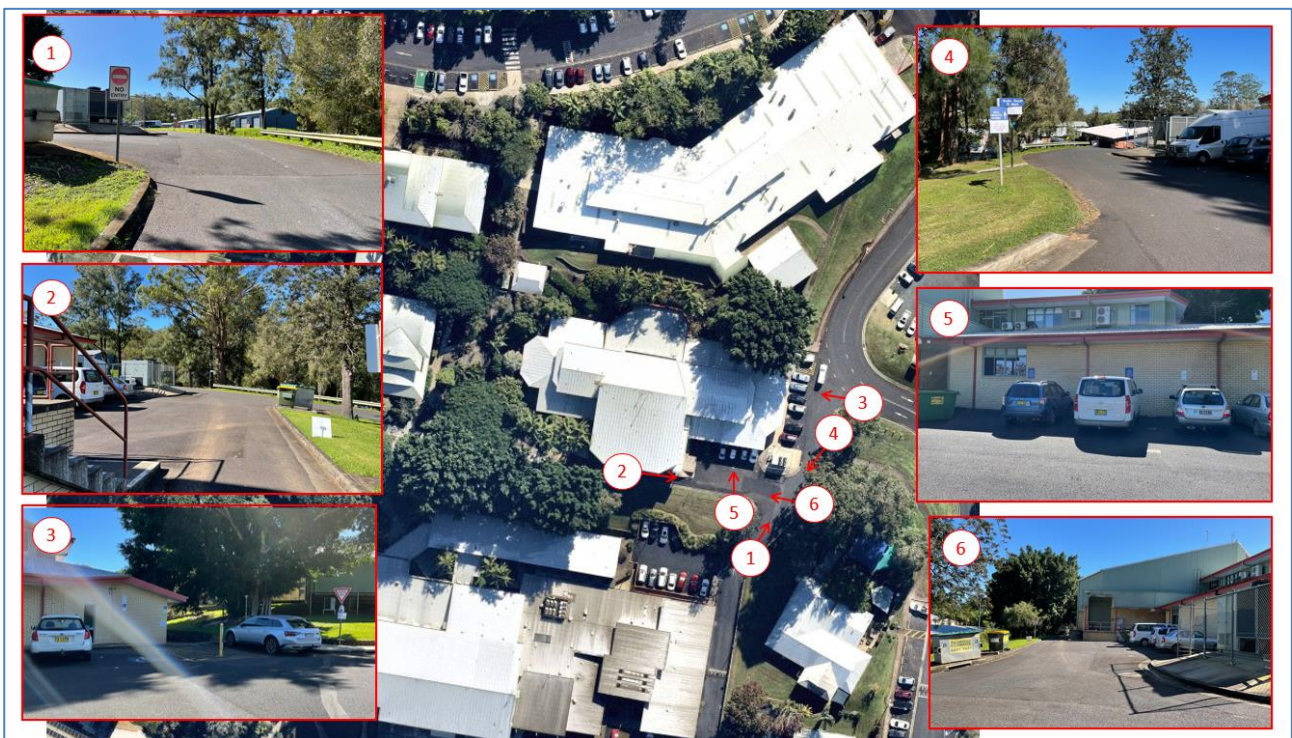
Figure 3.7: Site Area 5 Imagery

The parking area directly facing the access road includes 2 PWD space with common shared area (image 3). It was noted that associative signage to these spaces was mounting on the adjacent building, however these do not align properly with the spaces.

During the site visit it was noted that there are three loading bays to southern side of Block D (image 5), however these were all occupied for durations exceeding the signed time limit. Additionally, a space that is reserved for a specific number plated vehicle, was occupied by a different vehicle. There is also an elevated platform to facilitate servicing by larger vehicles without rear lift platform.

18. To the south of Block D, parking should be re-signed for general use, with a single loading bay clearly signed and line marked. The shared use of a loading bay between departments will encourage short term occupation. The loading area should encompass the loading platform to ensure accessibility is maintained.
19. SCU have advised that the 2 PWD spaces to the east of Block D may be reallocated to general parking. TTM do however recommend that 1 space remains (with one space being reallocated to general parking) to ensure accessibility – given the grades in the area not providing suitable access route from other parking areas to the building.
20. Remove car parking space at the side of Block H.

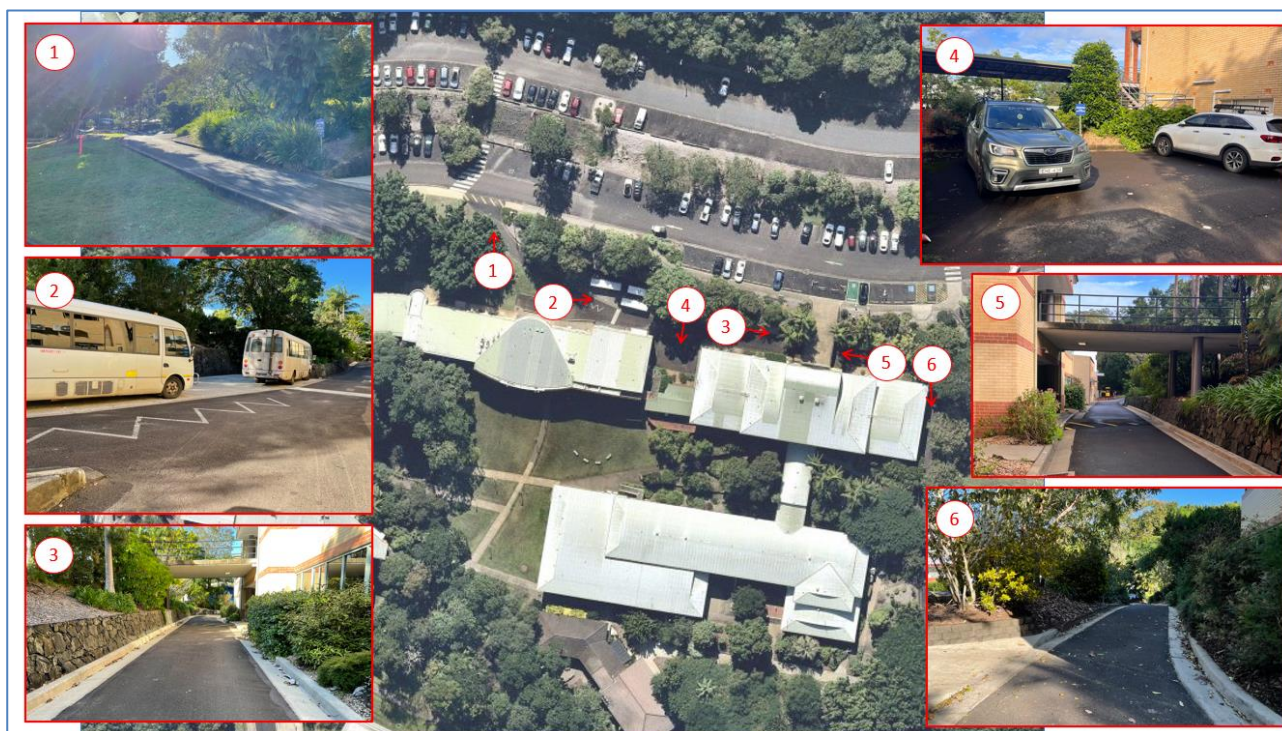
Figure 3.8: Site Area 6 Imagery

During the site inspection, TTM observed traffic operations during the end of the school day (pick up) and it was noted that all of those that arrived prior to the 3pm pick-up time parked in marked bays and walked to the school frontage to wait for their child. It was also observed that those who arrived, whilst children were departing the building, simply stopped at the edge of the through road – in front of parking bays – and their child crossed the road unassisted to the vehicle.

Vehicles were also seen to park within the motorcycle bays near to the access road entrance, as well as the two bays signed as “no parking”.

There are three parking spaces within the access road that have been allocated to the school (image 4).

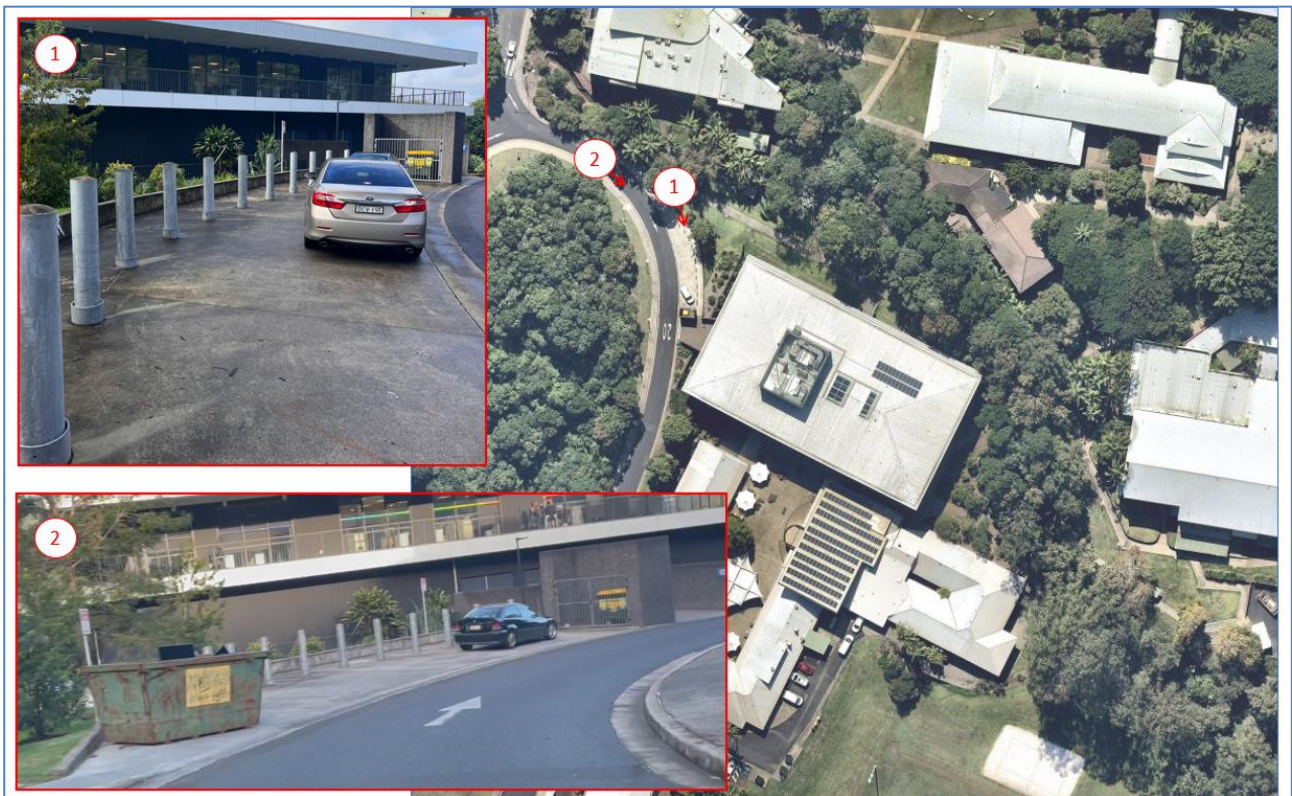
Figure 3.9: Site Area 7 Imagery

Containing the library, this area experiences limited vehicular activity. There is an off street loading bay located to west side of the building accessed directly from Military Road. TTM understand that the bay is often used by light vehicles for drop off/pick a s well as longer term parking – this is verified by aerial imagery over the time the bay has been in place.

There is also a pedestrian route that runs along the western edge of the loading bay, this is protected by heavy duty bollards. During the site inspection it was found that a skip was placed at the start of the bay – this was blocking the pedestrian route (image 2).

27. Introduce pavement marking identifying “loading zone only” (or similar) to clearly define as a no parking area. It is recommended that chevron hatching be included along the roadside edge to also assist with defining the area whilst also keeping the pedestrian access route clear of obstruction.

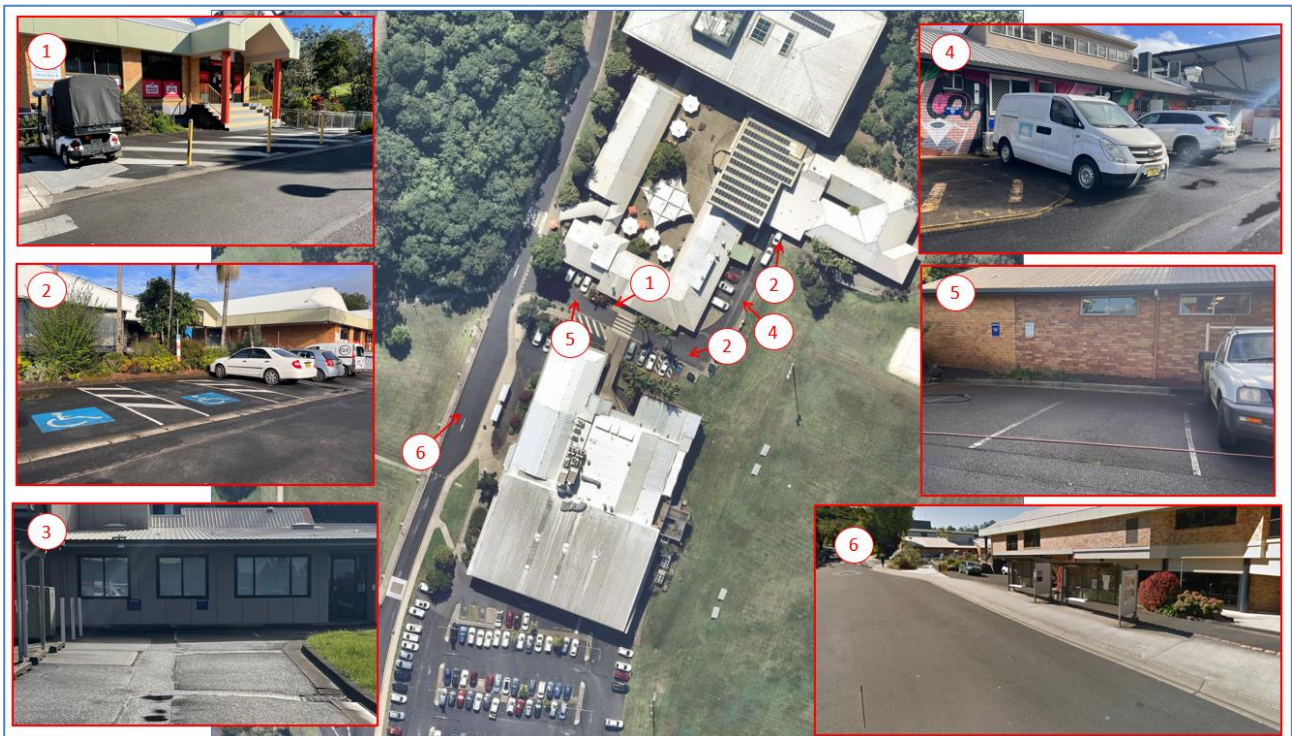
Figure 3.10: Site Area 7 Imagery

There is limited parking available around the food court cluster of buildings – the parking that is available is allocated to specific tenants. It is understood that SCU would like to retain:

- 2 marked bays to the plaza (image 4). One for LEXSA (Student Association) and one for the Quick Brown Fox Café.
- 2 marked bays for SCU staff (image 3).
- 2 PWD spaces with adjacent shared zone (image 3).

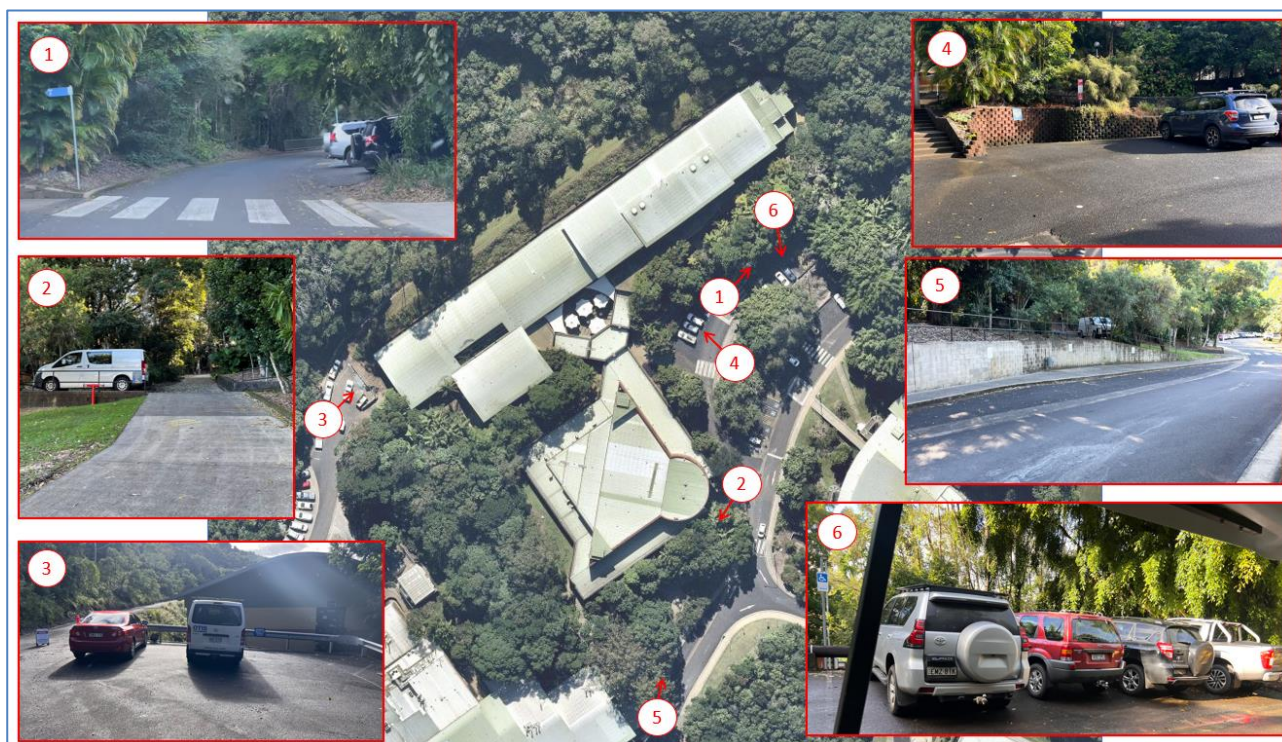
Figure 3.11: Site Area 9 Imagery

- School hours are 8.45am to 4.00pm, with staff being on site generally between 6.00am and 8.00pm.
- The school has 900 students and 140 staff.
- Students arriving by bus (from the off site interchange) are dropped off and picked up at the bus stop at the turnaround on Military Road. Students are required to walk between the stop and the school in Block R.
- There is no timetable of buses attending the site. It is essentially first students down first students on. There are generally 3 buses waiting when the students arrive at the stop (2 x Northern Rivers Buslines and 1 x Sodhi's). A further 2 arrive soon after and 2 more at around 3.12pm – these are Northern Rivers Buslines plus 1 from Simes.
- In the morning the students arrive at SCU by 9.00am.
- No buses associated with the school remain at SCU during the day.

During the site inspection, TTM observed student pedestrian flow at the end of the school day. TTM discussed the operation with a teacher on site at the time also. It was observed that students walk along the northern footpath, then cross University Road to the south side of the bus area - with a teacher acting as crossing patrol - then they walk along the southern footpath and cross the park area to the bus turnaround.

32. The turnaround is unable to accommodate the number of buses being used by the school, without blocking the access road to Block A and the circulation road. In order to limit impact to through traffic it is recommended that the end portion of the off street car park be reconfigured to provide for the additional buses. Access is already provided by way of footpaths and crossings and these are used by students being picked up by parents in the off street car park. The car park is observed to be under utilised and is expected to be able to accommodate the additional bus facility.

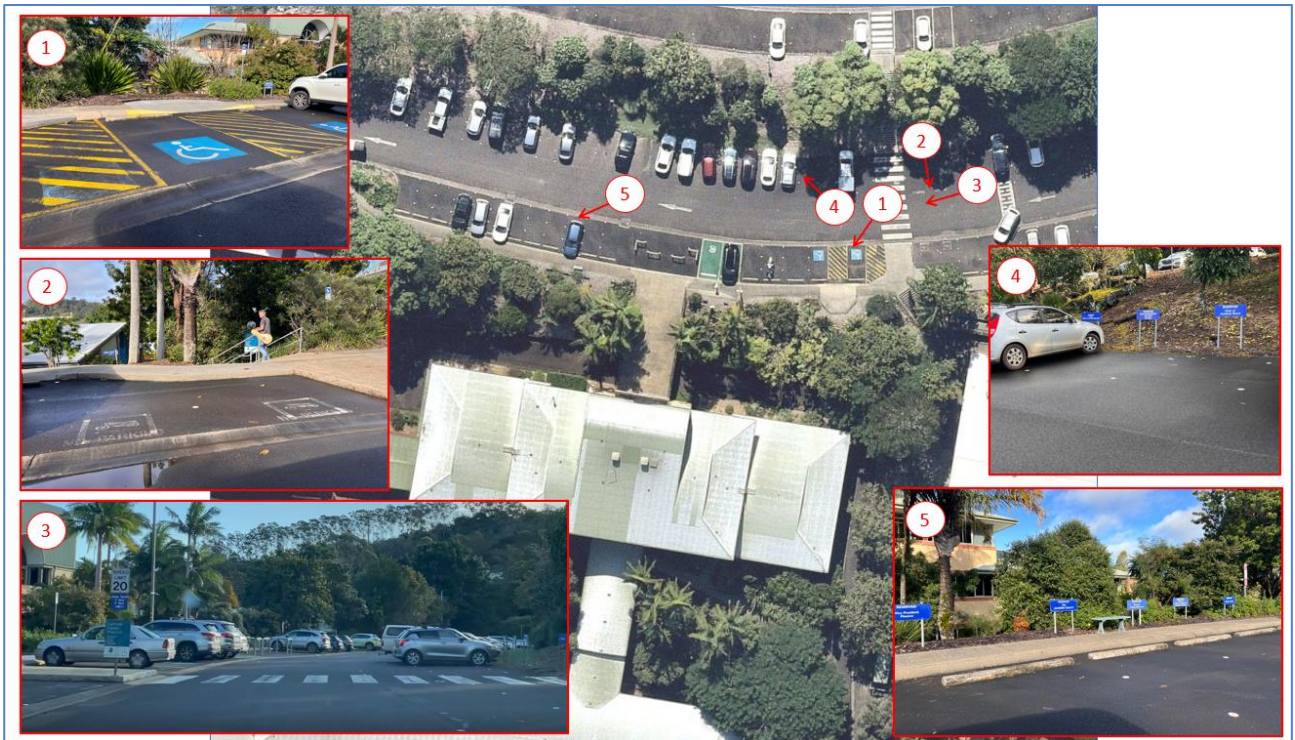
Figure 3.12: Site Area 10 Imagery

Accommodating the University executives, much of the parking at the immediate frontage of the building is reserved. It is proposed that these allocations remain.

There are also two electric vehicle spaces and two motorcycle spaces on the southern side of university Road.

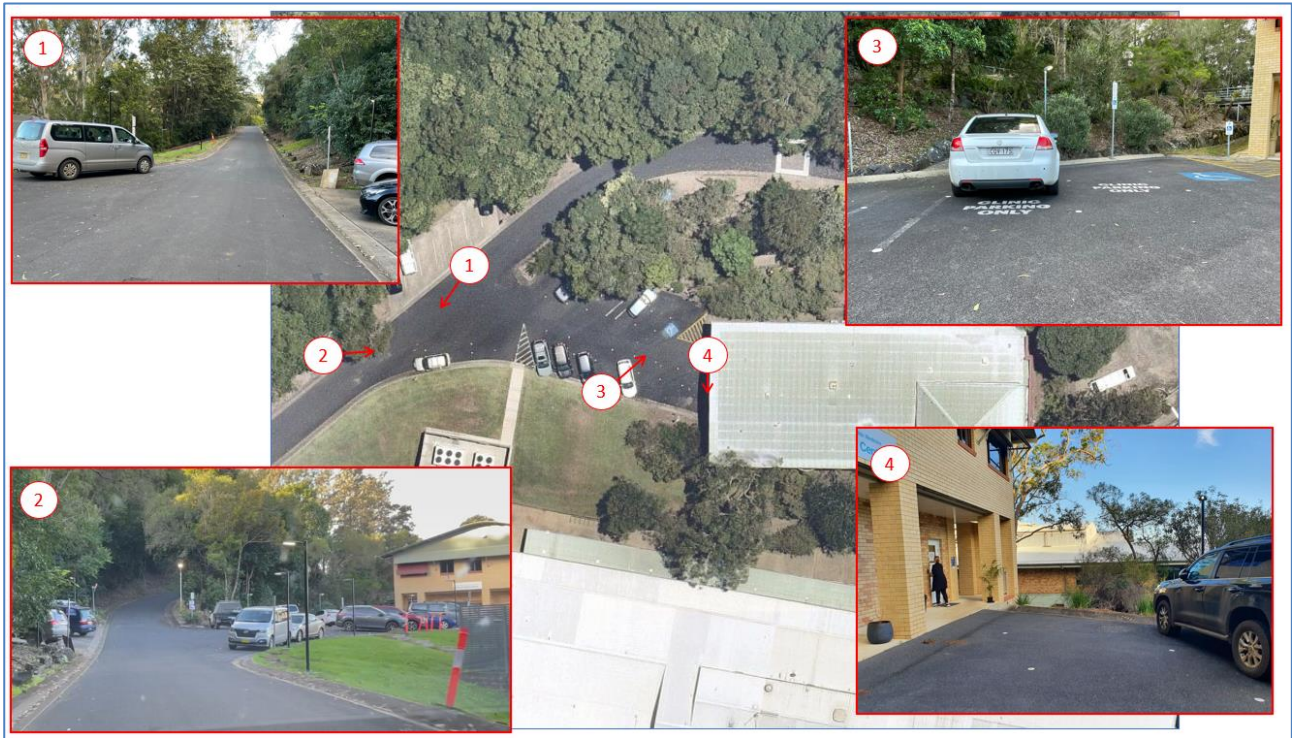
Figure 3.13: Site Area 11 Imagery

The car park immediately outside the building provides for 2 allocated clinic parking spaces and one PWD with adjacent shared space. All other spaces are signed for staff/student parking permit holders only.

- 38. Remove staff/student permit holder signage and replace with general parking with 2P limit.
- 39. Reline marking motorcycle parking to size 1.2m wide x 2.5m length.

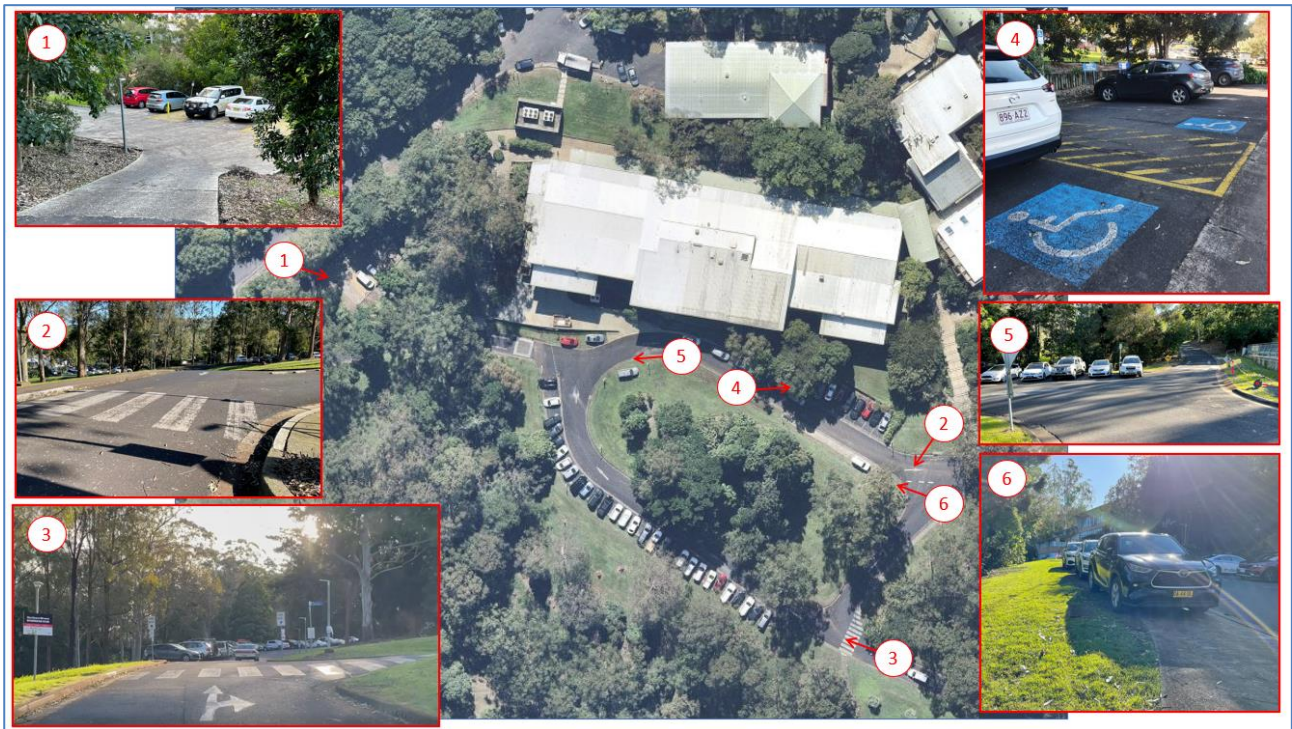
Figure 3.14: Site Area 12 Imagery

Encompassing Block A, this area accommodates the Faculty of Science & Engineering and more recently NSW Police. The site inspection identified several instances of non-compliant parking including across footpaths (image 6) and on verges. It was noted that attempt to rectify this has been done through the installation of temporary traffic bollards, however many of these had been knocked over.

PWD parking spaces were worn and did not include bollards within shared areas.

There is a small parking area to the north west side of the building (image 1). This is restricted to PWD parking, except one space which is allocated. TTM noted that the signs at the nose of these spaces are on a lean and the nose of spaces is protected only by a low kerb only – which allows the nose of vehicles to extend beyond the extents of the space.

On the approach to the turnaround, there is a digital speed limit sign that is set to the 20kph speed limit.

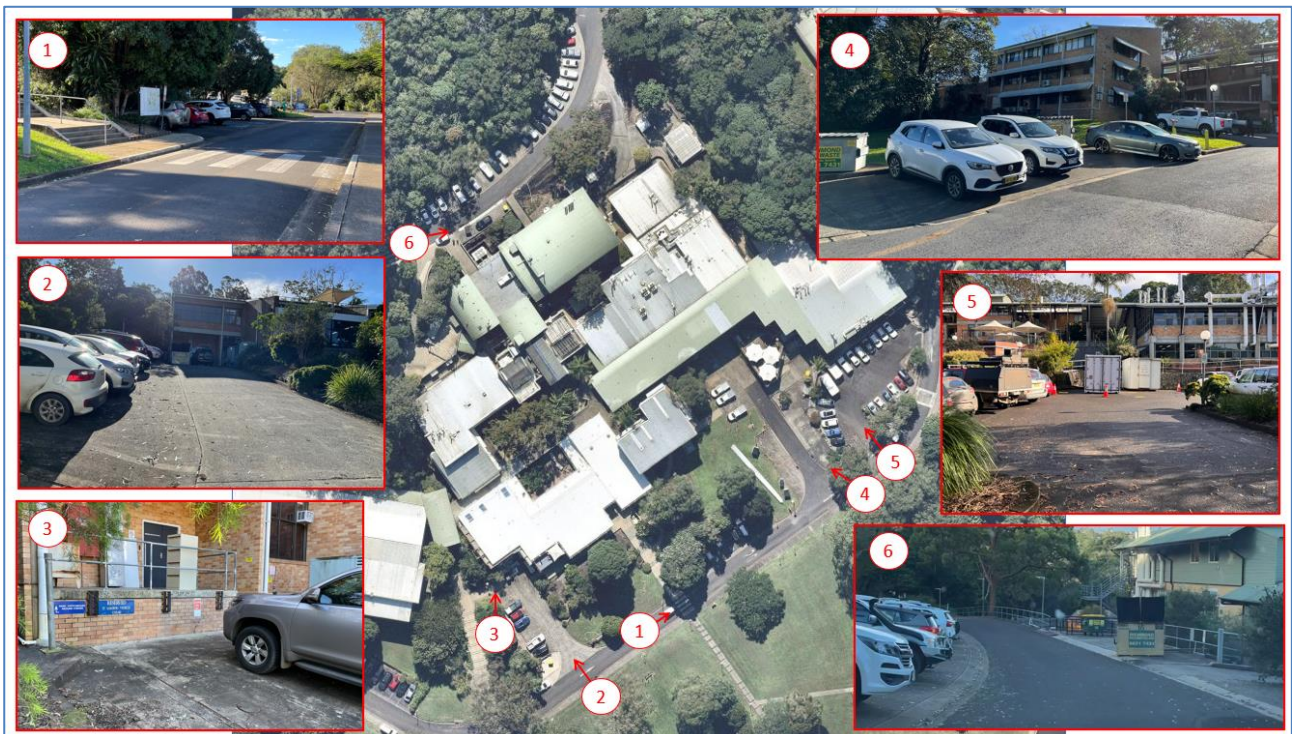
Figure 3.15: Site Area 13 Imagery

Vehicles were found to be parking in an area signed as bus stop, the parked vehicles also blocked access to waste bins that are located along the kerb of the bus stop area (image 4).

Parking provided at the rear of the building is all staff reserved (image 6) – given that the road is a no through road this allocation is advised to remain.

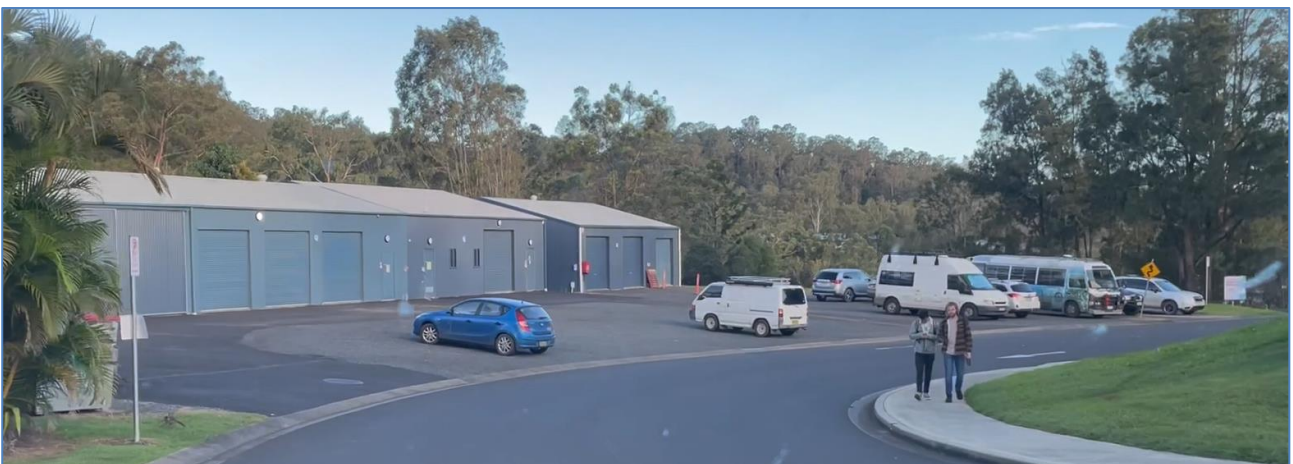
Figure 3.16: Site Area 14 Imagery

The area is required to remain open to access to the storage sheds so cannot be entirely blocked off.

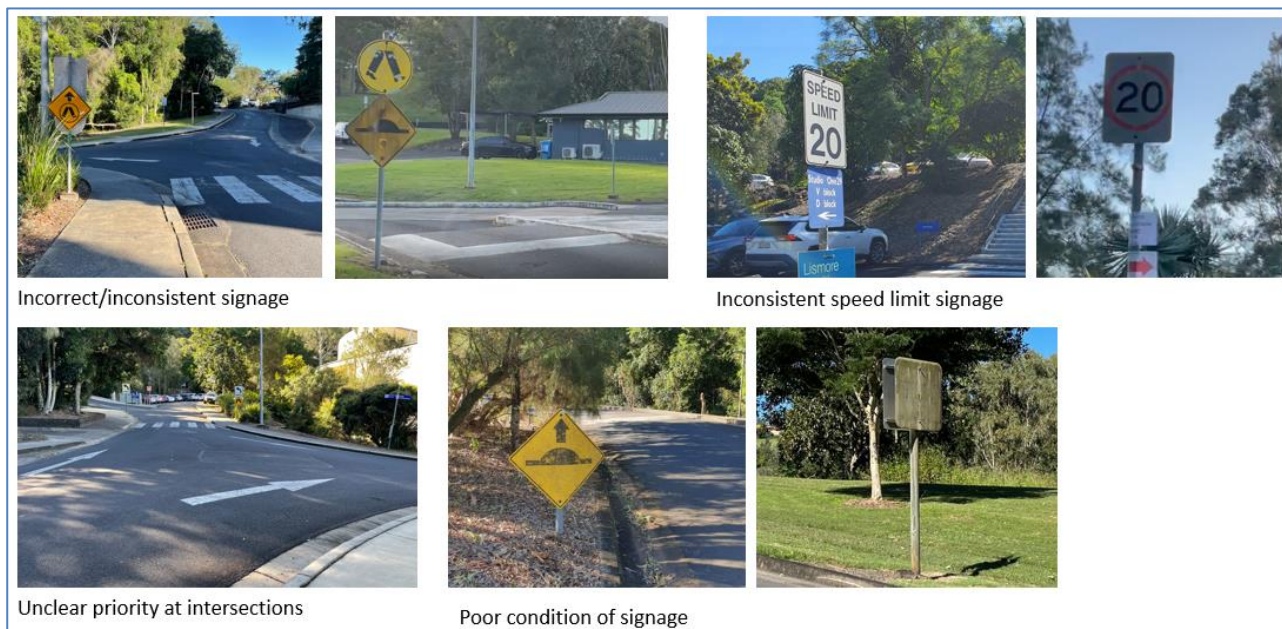
There is a disconnect with the consistency of speed limit representation, as well as incorrectly placed or inconsistent presentation of warnings of crossings and speed humps. Additionally, speed humps are in some cases difficult to see on approach.

52. The site would benefit significantly from an upgraded wayfinding strategy – with signage needing to allow for clear differentiation between vehicle signage that leads to parking, and pedestrian signage that directs along footpaths. This would be a key provision for the site and would help to limit the number and instances of vehicles re-circulating. Pedestrian signage should also include DDA routes for clarity of the user. The installation of wayfinding signage is particularly important at the Military Road entrance, whereby the majority of users should be directed to use the off street car parks.
